# Access Compliance Report Public Rights-of-Way (Curb Ramps)

Main Street: KEMPTON\_LN Cross Street: BLAKEMORE\_DR Location: N

ADA ID: RPRK211021144008 Ramp Type: Type 4 - Parallel Initial Pass/Fail: Fail Overall Compliance: No Severity Score: 32

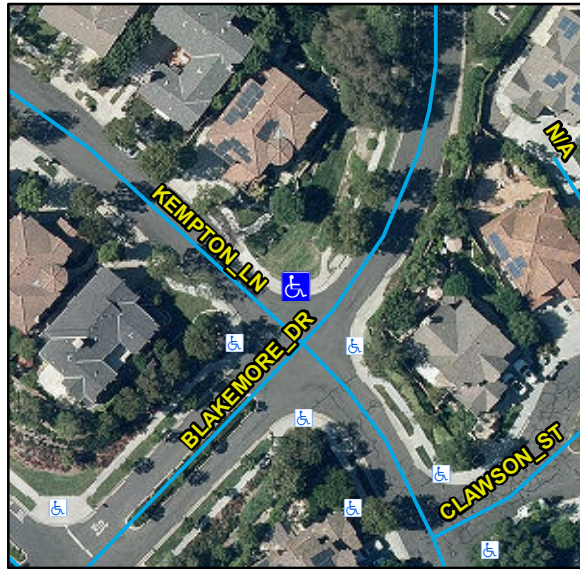
| Compliance | Description | Data | Compliance | Description | Data |
|---|---|---|---|---|---|
| Yes | Ramp Run Slope LT (%) | 2.6 | No | Ramp Run Slope RT (%) | 12.2 |
| No | Ramp Cross Slope LT (%) | 2.2 | No | Ramp Cross Slope RT (%) | 2.9 |

Remove & Replace Curb Ramp With Two New Directional Ramps or Equivalent.
