# Access Compliance Report Public Rights-of-Way (Curb Ramps)

| Main Street: BLAKEMORE_DR | | Cross Street: KEMPTON_LN | | Location: | E |
| ADA ID: RPRK211021144221 | Ramp Type: Type 4 - Parallel | Initial Pass/Fail: Fail | Overall Compliance: No | Severity Score: | 16 |

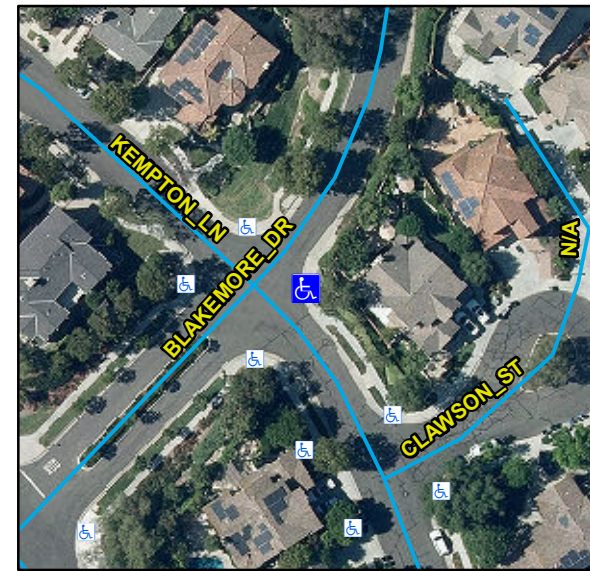
| Compliance | Description | Data | Compliance | Description | Data |
|---|---|---|---|---|---|
| No | Ramp Run Slope LT (%) | 8.7 | Yes | Ramp Run Slope RT (%) | 1.3 |
| No | Ramp Cross Slope LT (%) | 3.5 | No | Ramp Cross Slope RT (%) | 2.7 |

Possible Solutions:

**Remove & Replace Curb Ramp With Two New Directional Ramps or Equivalent.**

**R204.3, R304.3.2, R304.5.3, STD 1115**
