# Access Compliance Report Public Rights-of-Way (Curb Ramps)

Main Street: KEMPTON\_LN Cross Street: BLAKEMORE\_DR Location: S

ADA ID: RPRK211021144424 Ramp Type: Type 4 - Parallel Initial Pass/Fail: Fail Overall Compliance: No Severity Score: 2

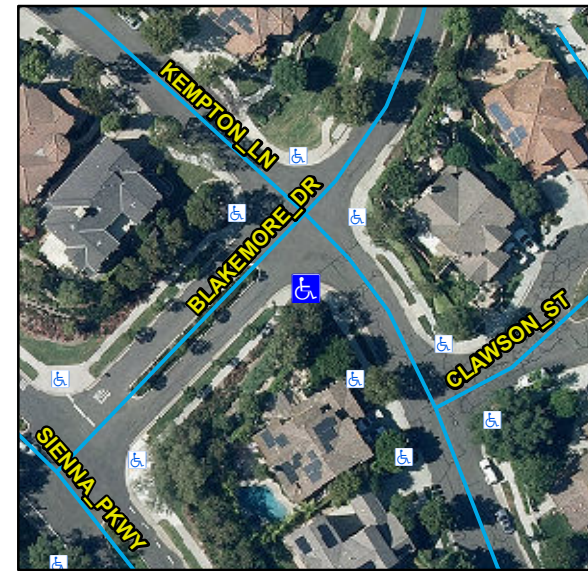
| Compliance | Description | Data | Compliance | Description | Data |
|---|---|---|---|---|---|
| No | Ramp Cross Slope LT (%) | 4.1 | Yes | Ramp Cross Slope RT (%) | 0.9 |

Remove & Replace Curb Ramp With Two New Directional Ramps or Equivalent.

R204.3, R304.5.3, STD 1115
