# Access Compliance Report Public Rights-of-Way (Curb Ramps)

Main Street: KEMPTON\_LN Cross Street: CLAWSON\_ST Location: NE

ADA ID: RPRK211021152600 Ramp Type: Type 4 - Parallel Initial Pass/Fail: Fail Overall Compliance: No Severity Score: 16

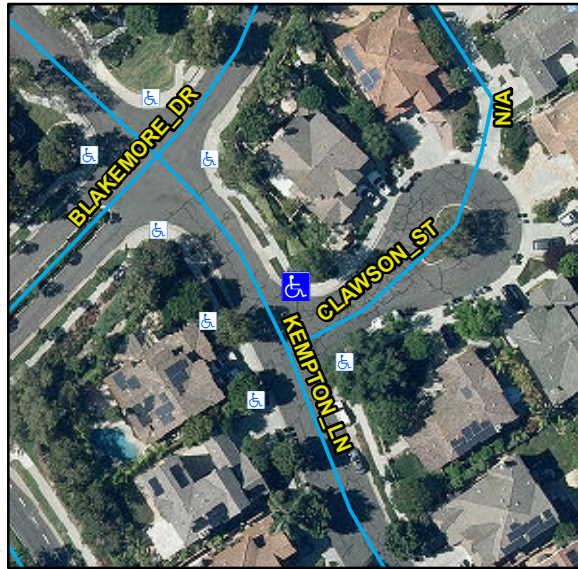
R204.3, R304.3.2, R304.5.3, STD 1115

| Compliance | Description | Data | Compliance | Description | Data |
|---|---|---|---|---|---|
| No | Ramp Run Slope LT (%) | 10.8 | Yes | Ramp Run Slope RT (%) | 5.7 |
| Yes | Ramp Cross Slope LT (%) | 0.7 | No | Ramp Cross Slope RT (%) | 2.4 |

Remove & Replace Curb Ramp With Two New Directional Ramps or Equivalent.
