# Access Compliance Report Public Rights-of-Way (Curb Ramps)

| Main Street: CLAWSON_ST | | Cross Street: KEMPTON_LN | | Location: | SE |
| ADA ID: RPRK211021153242 | Ramp Type: Type 4 - Parallel | Initial Pass/Fail: Fail | Overall Compliance: No | Severity Score: | 32 |

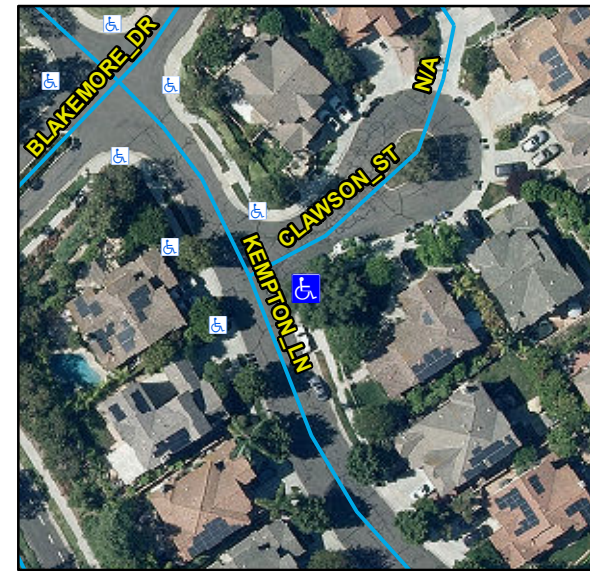
| Compliance | Description | Data | Compliance | Description | Data |
|---|---|---|---|---|---|
| No | Ramp Run Slope LT (%) | 12.3 | Yes | Ramp Run Slope RT (%) | 6.1 |
| Yes | Ramp Cross Slope LT (%) | 1.3 | No | Ramp Cross Slope RT (%) | 3.4 |

**Remove & Replace Curb Ramp With Two New Directional Ramps or Equivalent.**

**R204.3, R304.3.2, R304.5.3, STD 1115**
