# Access Compliance Report Public Rights-of-Way (Curb Ramps)

Main Street: KEMPTON\_LN Cross Street: HEMPSTEAD\_ST Location: NE

ADA ID: RPRK211021154134 Ramp Type: Type 4 - Parallel Initial Pass/Fail: Fail Overall Compliance: No Severity Score: 16

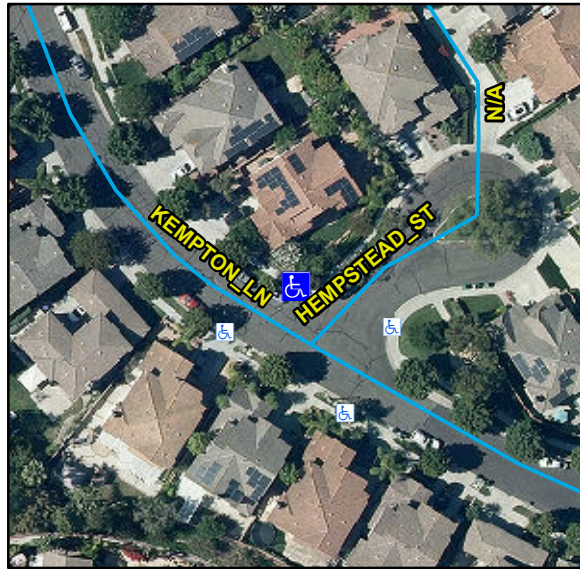
| Compliance | Description | Data | Compliance | Description | Data |
|---|---|---|---|---|---|
| No | Ramp Run Slope LT (%) | 8.4 | Yes | Ramp Run Slope RT (%) | 6.8 |
| No | Ramp Cross Slope LT (%) | 3.6 | No | Ramp Cross Slope RT (%) | 3.3 |

**Remove & Replace Curb Ramp With Two New Directional Ramps or Equivalent.**

**R204.3, R304.3.2, R304.5.3, STD 1115**
