# Access Compliance Report Public Rights-of-Way (Curb Ramps)

Main Street: HEMPSTEAD\_ST Cross Street: KEMPTON\_LN Location: SE

ADA ID: RPRK211021154647 Ramp Type: Type 4 - Parallel Initial Pass/Fail: Pass Overall Compliance: No Severity Score: 25

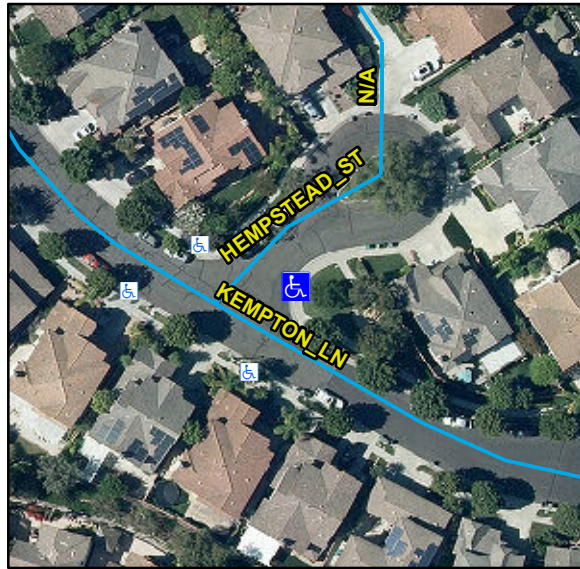
| Compliance | Description | Data | Compliance | Description | Data |
|---|---|---|---|---|---|
| N/A | Landing Present | No | No | DWS Provided | No |
| No | Landing Width (in) | N/A | N/A | DWS Length (in) | N/A |
| No | Landing Run Slope (%) | N/A | N/A | DWS Full Width | N/A |
| No | Landing Cross Slope (%) | N/A | | DWS Offset Type | N/A |
| Yes | Gutter Ponding | No | No | Curb Slope | 8.7 |
| No | Gutter Run Slope (%) | 6.6 | | Road Cross Slope (%) | 5.2 |

Remove & Replace Curb Ramp With Two New Directional Ramps or Equivalent. Remove & Replace Gutter.

R304.2.2, R204.3, R304.2.1, R304.2.2-Perp, R304.3.2-Para, R304.5.3, R305, R304.5.4, STD 1115

Total Cost: \$ 4252
