# Access Compliance Report Public Rights-of-Way (Curb Ramps)

Main Street: KYLE\_CT Cross Street: KYLE\_CT Location: SW

ADA ID: RPRK211021160508 Ramp Type: Type 4 - Parallel Initial Pass/Fail: Fail Overall Compliance: No Severity Score: 32

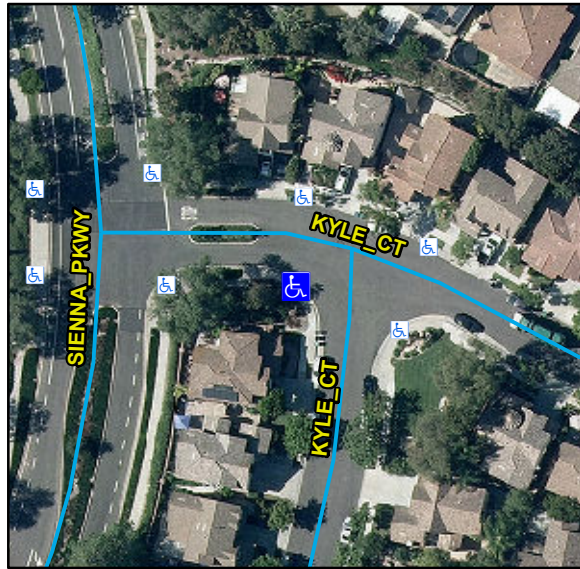
| Compliance | Description | Data | Compliance | Description | Data |
|---|---|---|---|---|---|
| No | Ramp Run Slope LT (%) | 15.4 | Yes | Ramp Run Slope RT (%) | 4 |
| No | Ramp Cross Slope LT (%) | 2.6 | Yes | Ramp Cross Slope RT (%) | 0.1 |

Remove & Replace Curb Ramp With Two New Directional Ramps or Equivalent.
