# Access Compliance Report Public Rights-of-Way (Curb Ramps)

Main Street: KYLE\_CT Cross Street: KYLE\_CT Location: S

ADA ID: RPRK211021161142 Ramp Type: Type 4 - Parallel Initial Pass/Fail: Fail Overall Compliance: No Severity Score: 2

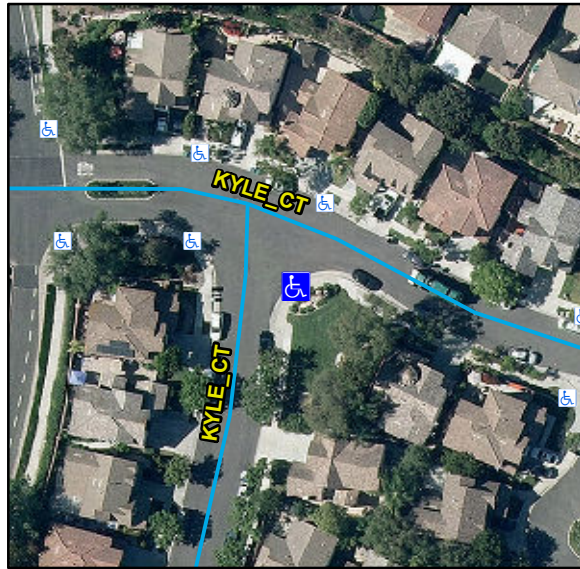
| Compliance | Description | Data | Compliance | Description | Data |
|---|---|---|---|---|---|
| Yes | Ramp Run Slope LT (%) | 7.3 | Yes | Ramp Run Slope RT (%) | 3.6 |
| No | Ramp Cross Slope LT (%) | 2.8 | No | Ramp Cross Slope RT (%) | 2.2 |

**Remove & Replace Curb Ramp With Two New Directional Ramps or Equivalent.**

**R204.3, R304.5.3, STD 1115**
