# Access Compliance Report Public Rights-of-Way (Curb Ramps)

Main Street: SIENNA\_PKWY Cross Street: KYLE\_CT Location: E

ADA ID: RPRK211021163617 Ramp Type: Blended Transition 1 Initial Pass/Fail: Fail Overall Compliance: No Severity Score: 16

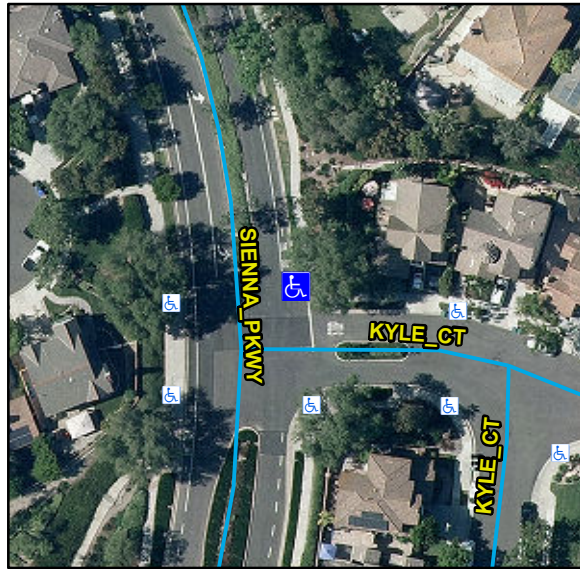
| Compliance | Description | Data | Compliance | Description | Data |
|---|---|---|---|---|---|
| No | Ramp Run Slope (%) | 6.8 | N/A | Flare Slope RT (%) | N/A |
| No | Ramp Cross Slope (%) | 2.8 | N/A | Flare Traversable RT | N/A |

Remove & Replace Curb Ramp With Two New Directional Ramps or Equivalent.
