# Access Compliance Report Public Rights-of-Way (Curb Ramps)

Main Street: KYLE\_CT Cross Street: SIENNA\_PKWY Location: S

ADA ID: RPRK211021164252 Ramp Type: Blended Transition 1 Initial Pass/Fail: Pass Overall Compliance: No Severity Score: 40

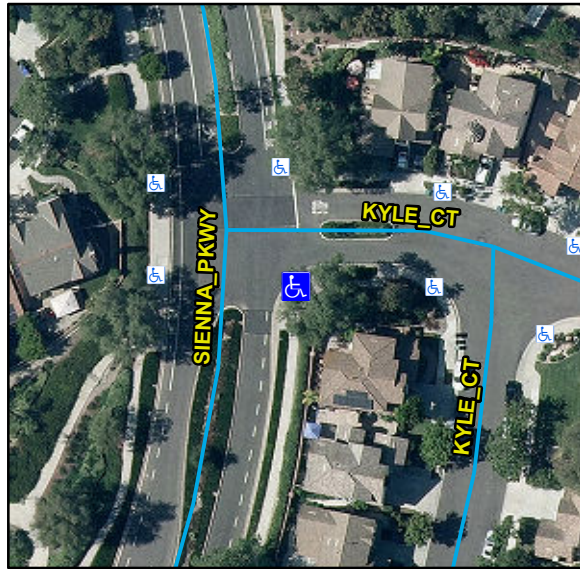
| Compliance | Description | Data | Compliance | Description | Data |
|---|---|---|---|---|---|
| No | Ramp Run Slope (%) | 7.9 | N/A | Flare Slope RT (%) | 7.7 |
| N/A | Landing Present | No | No | DWS Provided | No |
| No | Gutter Run Slope (%) | 9.3 | | Road Cross Slope (%) | 3.9 |

Remove & Replace Curb Ramp With Two New Directional Ramps or Equivalent. Remove & Replace Gutter.
