# Access Compliance Report Public Rights-of-Way (Curb Ramps)

Main Street: **MERCANTILE\_WAY** Cross Street: **SIENNA\_PKWY** Location: **SW**

ADA ID: **RPRK211022121254** Ramp Type: **Blended Transition 1** Initial Pass/Fail: **Fail** Overall Compliance: **No** Severity Score: **15**

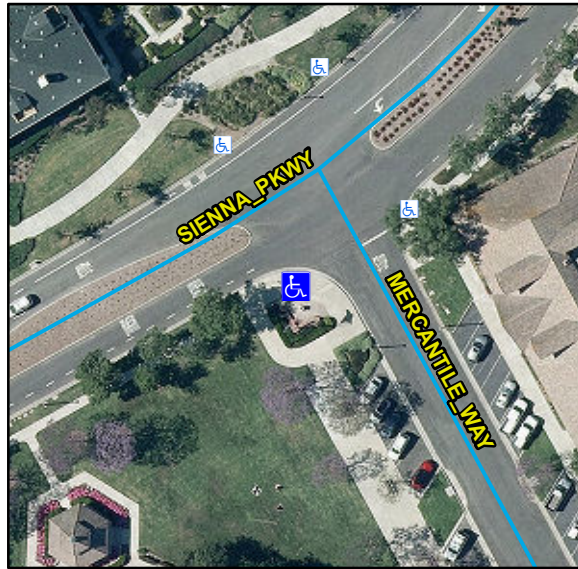
| Compliance | Description | Data | Compliance | Description | Data |
|---|---|---|---|---|---|
| <b>No</b> | Ramp Cross Slope (%) | <b>5.2</b> | <b>N/A</b> | Flare Traversable RT | <b>N/A</b> |
| <b>N/A</b> | Gutter Ponding | <b>N/A</b> | <b>No</b> | Curb Slope | <b>5.1</b> |

**Remove & Replace Curb Ramp With Two New Directional Ramps or Equivalent.**
