# Access Compliance Report Public Rights-of-Way (Curb Ramps)

| Main Street: SIENNA_PKWY | | Cross Street: MERCANTILE_WAY | | Location: | SE |
| ADA ID: RPRK211022121512 | Ramp Type: Blended Transition 1 | Initial Pass/Fail: Pass | Overall Compliance: No | Severity Score: | 40 |

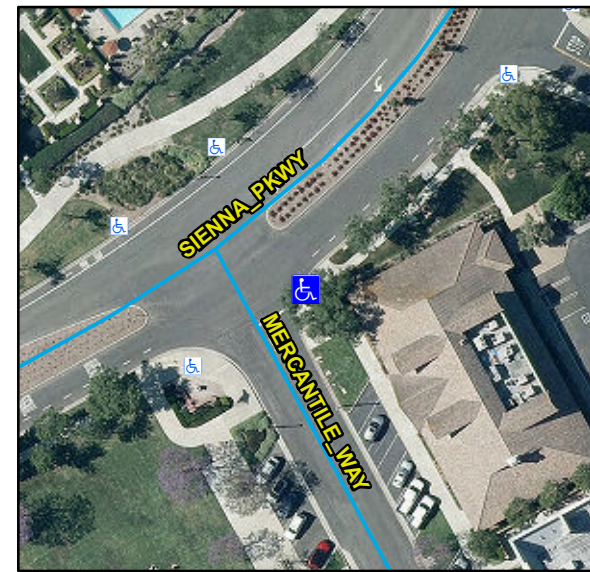
| Compliance | Description | Data | Compliance | Description | Data |
|---|---|---|---|---|---|
| No | Ramp Run Slope (%) | 5.1 | Yes | Flare Slope RT (%) | 7.6 |
| N/A | Landing Present | No | No | DWS Provided | No |
| No | Gutter Run Slope (%) | 9.7 | | Road Cross Slope (%) | 7 |

**Remove & Replace Curb Ramp With Two New Directional Ramps or Equivalent. Remove & Replace Gutter.**

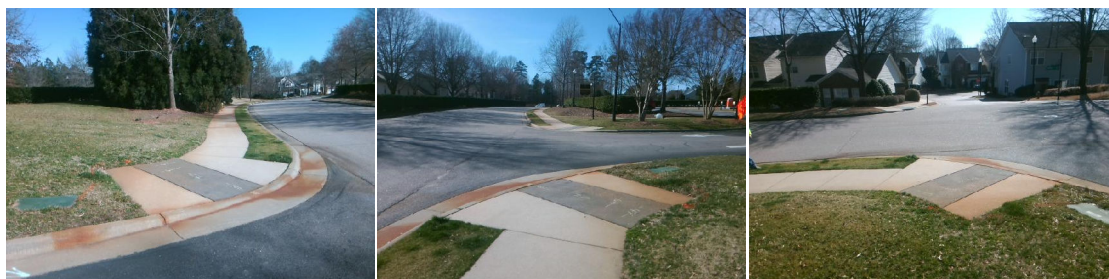
| Compliance | Description | Data | Compliance | Description | Data |
|---|---|---|---|---|---|
| N/A | Ramp Length (in) | 97 | Yes | Flare Slope LT (%) | 6 |
| Yes | Ramp Width (in) | 48 | N/A | Flare Traversable LT | Yes |
| Yes | Ramp Cross Slope (%) | 0.4 | N/A | Flare Traversable RT | Yes |
| Yes | Gutter Ponding | No | No | Curb Slope | 7.8 |
| Yes | Gutter Lip Height (in) | 0 | | Road Run Slope (%) | 1.6 |
