# Access Compliance Report Public Rights-of-Way (Curb Ramps)

Main Street: SIENNA\_PKWY Cross Street: MERCANTILE\_WAY Location: E

ADA ID: RPRK211022122137 Ramp Type: Type 4 - Parallel Initial Pass/Fail: Pass Overall Compliance: No Severity Score: 26

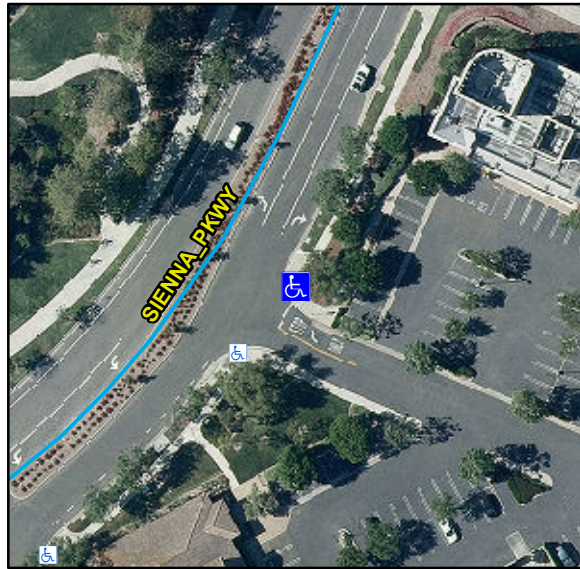
| Compliance | Description | Data | Compliance | Description | Data |
|---|---|---|---|---|---|
| N/A | Landing Present | No | No | DWS Provided | No |
| No | Landing Width (in) | N/A | N/A | DWS Length (in) | N/A |
| No | Landing Run Slope (%) | N/A | N/A | DWS Full Width | N/A |
| No | Landing Cross Slope (%) | N/A | | DWS Offset Type | N/A |
| Yes | Gutter Ponding | No | No | Curb Slope | 8.5 |
| No | Gutter Run Slope (%) | 6.1 | | Road Cross Slope (%) | 0.2 |

Remove & Replace Curb Ramp With Two New Directional Ramps or Equivalent. Remove & Replace Gutter.

R304.2.2, R204.3, R304.2.1, R304.2.2-Perp, R304.3.2-Para, R304.5.3, R305, R304.5.4, STD 1115
