# Access Compliance Report Public Rights-of-Way (Curb Ramps)

Main Street: **MERCANTILE\_WAY** Cross Street: **SIENNA\_PKWY** Location: **S**

ADA ID: **RPRK211022122524** Ramp Type: **Type 4 - Parallel** Initial Pass/Fail: **Fail** Overall Compliance: **No** Severity Score: **45**

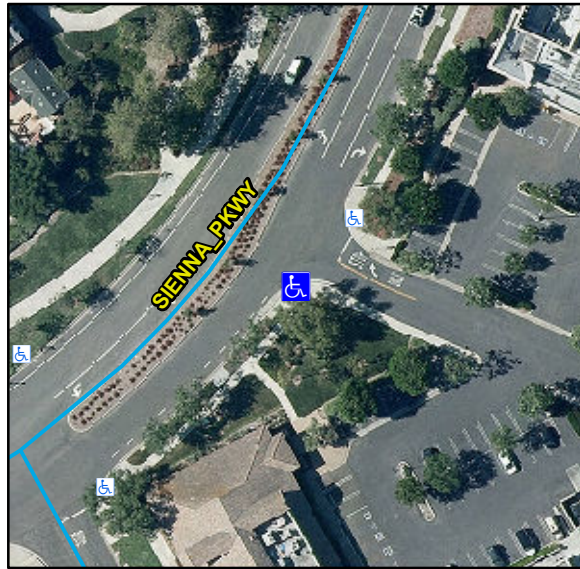
| Compliance | Description | Data | Compliance | Description | Data |
|---|---|---|---|---|---|
| Yes | Ramp Run Slope LT (%) | 4.2 | No | Ramp Run Slope RT (%) | 8.7 |
| Yes | Ramp Cross Slope LT (%) | 0.2 | No | Ramp Cross Slope RT (%) | 7.2 |

**Remove & Replace Curb Ramp With Two New Directional Ramps or Equivalent.**
