# Access Compliance Report Public Rights-of-Way (Curb Ramps)

Main Street: SIENNA\_PKWY Cross Street: MAIN\_ST Location: SE

ADA ID: RPRK211022123034 Ramp Type: Type 4 - Parallel Initial Pass/Fail: Pass Overall Compliance: No Severity Score: 26

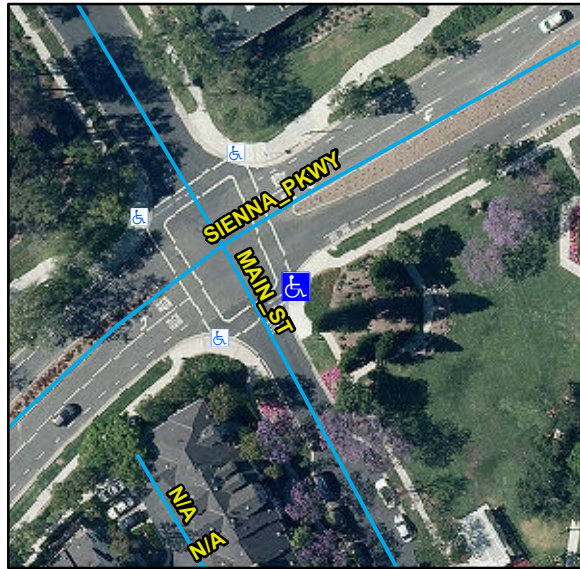
| Compliance | Description | Data | Compliance | Description | Data |
|---|---|---|---|---|---|
| N/A | Landing Present | No | No | DWS Provided | No |
| No | Landing Width (in) | N/A | N/A | DWS Length (in) | N/A |
| No | Landing Run Slope (%) | N/A | N/A | DWS Full Width | N/A |
| No | Landing Cross Slope (%) | N/A | | DWS Offset Type | N/A |
| No | Gutter Run Slope (%) | 9.6 | | Road Cross Slope (%) | 1.5 |
| No | Gutter Cross Slope (%) | 4.4 | No | Perpendicular Joint Present | No |

Remove & Replace Curb Ramp With Two New Directional Ramps or Equivalent. Remove & Replace Gutter.
