# Access Compliance Report Public Rights-of-Way (Curb Ramps)

Main Street: MAIN\_ST Cross Street: SIENNA\_PKWY Location: NE

ADA ID: RPRK211022123442 Ramp Type: Type 4 - Parallel Initial Pass/Fail: Fail Overall Compliance: No Severity Score: 15

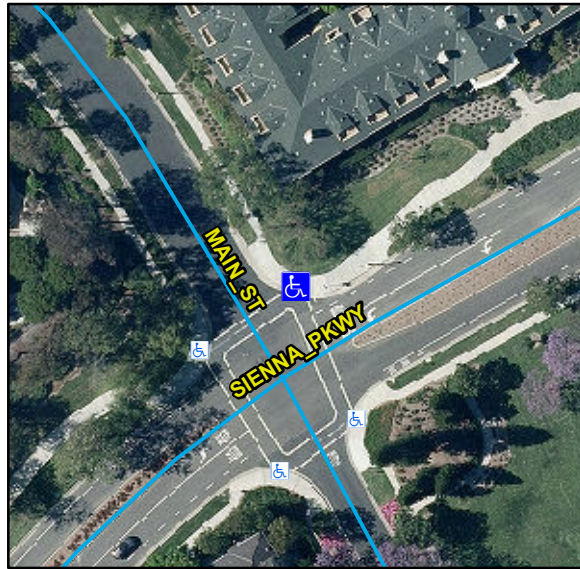
| Compliance | Description | Data | Compliance | Description | Data |
|---|---|---|---|---|---|
| No | Ramp Cross Slope LT (%) | 7 | No | Ramp Cross Slope RT (%) | 2.3 |
| N/A | Gutter Ponding | N/A | No | Curb Slope | 11.3 |

Remove & Replace Curb Ramp With Two New Directional Ramps or Equivalent.

R304.2.2, R204.3, R304.5.3, STD 1115

Total Cost: \$ 4000
