# Access Compliance Report Public Rights-of-Way (Curb Ramps)

Main Street: MAIN\_ST Cross Street: SIENNA\_PKWY Location: SW

ADA ID: RPRK211022123736 Ramp Type: Type 4 - Parallel Initial Pass/Fail: Fail Overall Compliance: No Severity Score: 30

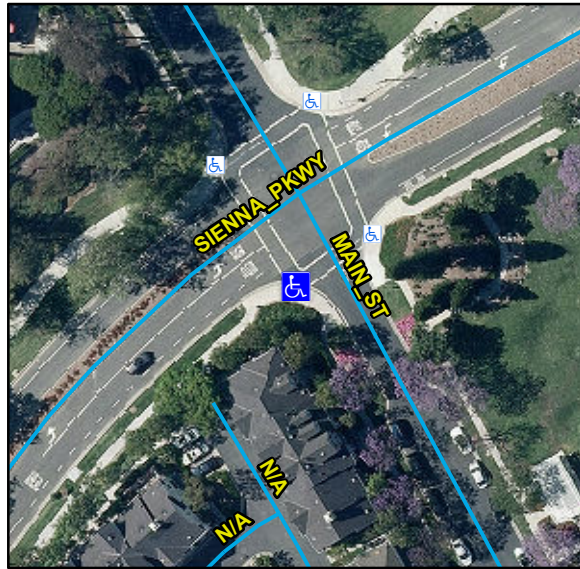
R204.3, R304.5.3, STD 1115

| Compliance | Description | Data | Compliance | Description | Data |
|---|---|---|---|---|---|
| No | Ramp Cross Slope LT (%) | 5.2 | No | Ramp Cross Slope RT (%) | 7.8 |

Remove & Replace Curb Ramp With Two New Directional Ramps or Equivalent.
