# Access Compliance Report Public Rights-of-Way (Curb Ramps)

| Main Street: SIENNA_PKWY | | Cross Street: MAIN_ST | | Location: | NW |

| ADA ID: RPRK211022124056 | Ramp Type: Type 4 - Parallel | Initial Pass/Fail: Fail | Overall Compliance: No | Severity Score: | 45 |

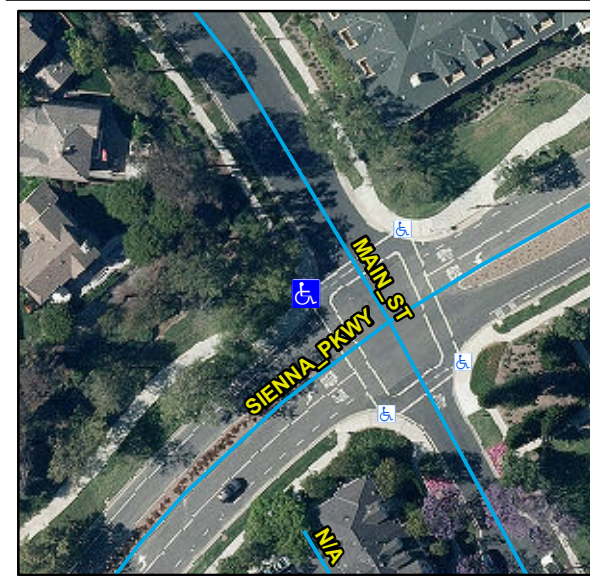
| Compliance | Description | Data | Compliance | Description | Data |
|---|---|---|---|---|---|
| Yes | Ramp Run Slope LT (%) | 0.7 | No | Ramp Run Slope RT (%) | 9 |
| No | Ramp Cross Slope LT (%) | 6.9 | No | Ramp Cross Slope RT (%) | 8.6 |
| N/A | Gutter Cross Slope (%) | N/A | No | Perpendicular Joint Present | No |

| Remove & Replace Curb Ramp With Two New Directional Ramps or Equivalent. | |
| R204.3, R304.5.3, R304.3.2, STD 1115 | |
