# Access Compliance Report Public Rights-of-Way (Curb Ramps)

Main Street: MAYBECK\_LN Cross Street: COURTNEY\_CIR Location: S

ADA ID: RPRK211025113638 Ramp Type: Type 4 - Parallel Initial Pass/Fail: Fail Overall Compliance: No Severity Score: 15

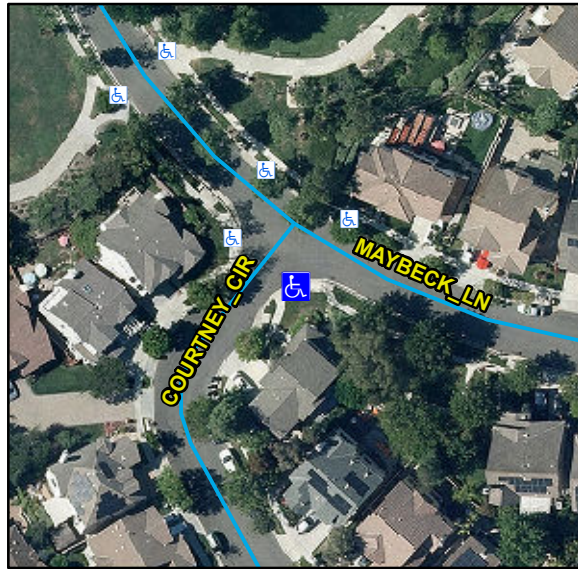
| Compliance | Description | Data | Compliance | Description | Data |
|---|---|---|---|---|---|
| No | Ramp Run Slope LT (%) | 11.4 | Yes | Ramp Run Slope RT (%) | 2.3 |

**Remove & Replace Curb Ramp With Two New Directional Ramps or Equivalent.**

**R204.3, R304.3.2, STD 1115**
