# Access Compliance Report Public Rights-of-Way (Curb Ramps)

| Main Street: COURTNEY_CIR | | Cross Street: MAYBECK_LN | | Location: | W |
| ADA ID: RPRK211025113818 | Ramp Type: Type 4 - Parallel | Initial Pass/Fail: Fail | Overall Compliance: No | Severity Score: | 32 |

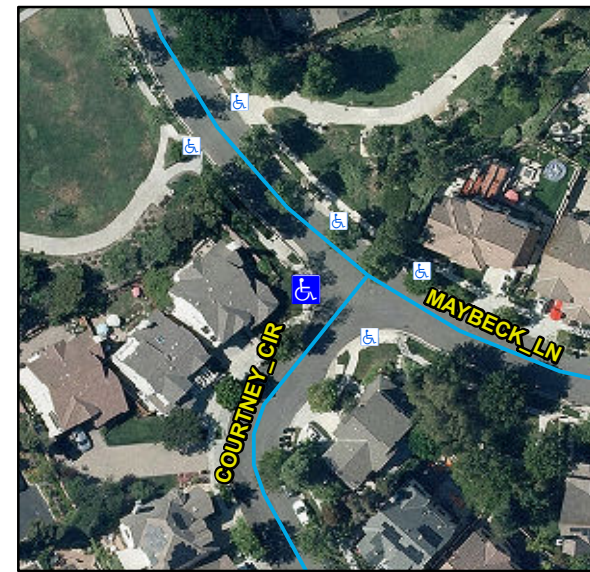
| Compliance | Description | Data | Compliance | Description | Data |
|---|---|---|---|---|---|
| No | Ramp Run Slope LT (%) | 12.2 | Yes | Ramp Run Slope RT (%) | 4.4 |
| No | Ramp Cross Slope LT (%) | 3.5 | Yes | Ramp Cross Slope RT (%) | 1.3 |

**Remove & Replace Curb Ramp With Two New Directional Ramps or Equivalent.**

**R204.3, R304.3.2, R304.5.3, STD 1115**

Total Cost: \$ 4000
