# Access Compliance Report Public Rights-of-Way (Curb Ramps)

Main Street: DAWNWOOD Cross Street: WHISPER\_CIR Location: E

ADA ID: RPRK211025114732 Ramp Type: Type 4 - Parallel Initial Pass/Fail: Fail Overall Compliance: No Severity Score: 16

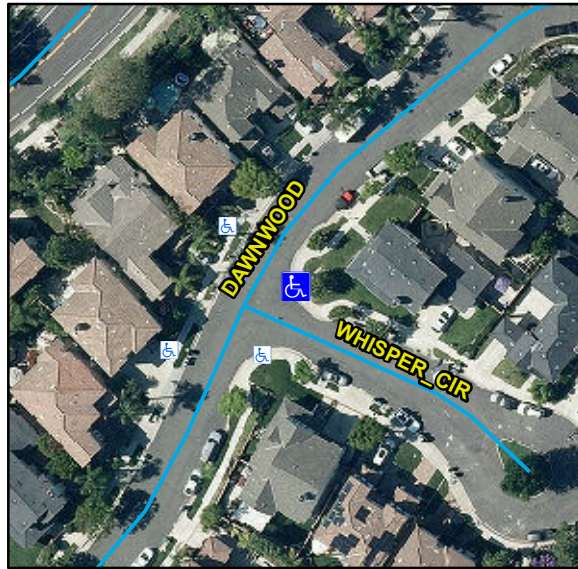
| Compliance | Description | Data | Compliance | Description | Data |
|---|---|---|---|---|---|
| No | Ramp Run Slope LT (%) | 9.3 | Yes | Ramp Run Slope RT (%) | 3.8 |
| Yes | Ramp Cross Slope LT (%) | 1.5 | No | Ramp Cross Slope RT (%) | 2.2 |

**Remove & Replace Curb Ramp With Two New Directional Ramps or Equivalent.**

**R204.3, R304.3.2, R304.5.3, STD 1115**

Total Cost: \$ 4000
