# Access Compliance Report Public Rights-of-Way (Curb Ramps)

Main Street: WHISPER\_CIR Cross Street: DAWNWOOD Location: S

ADA ID: RPRK211025114914 Ramp Type: Type 4 - Parallel Initial Pass/Fail: Fail Overall Compliance: No Severity Score: 2

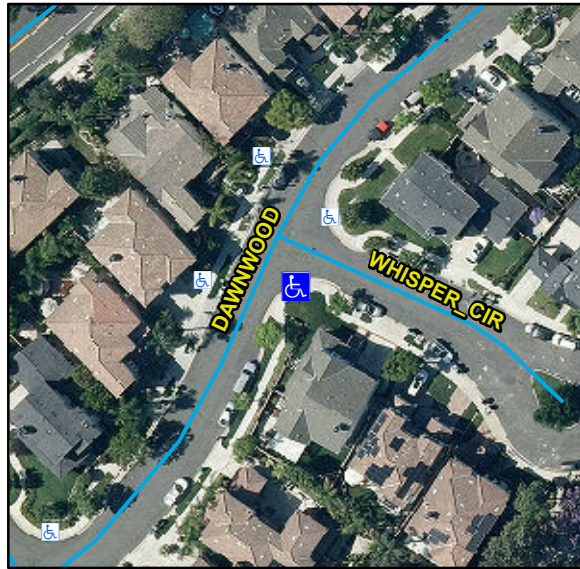
| Compliance | Description | Data | Compliance | Description | Data |
|---|---|---|---|---|---|
| No | Ramp Cross Slope LT (%) | 3.4 | No | Ramp Cross Slope RT (%) | 2.9 |

**Remove & Replace Curb Ramp With Two New Directional Ramps or Equivalent.**

**R204.3, R304.5.3, STD 1115**
