# Access Compliance Report Public Rights-of-Way (Curb Ramps)

| Main Street: CALM_CREEK_CIR | | Cross Street: DAWNWOOD | | Location: | NE |
| ADA ID: RPRK211025115118 | Ramp Type: Type 4 - Parallel | Initial Pass/Fail: Fail | Overall Compliance: No | Severity Score: | 15 |

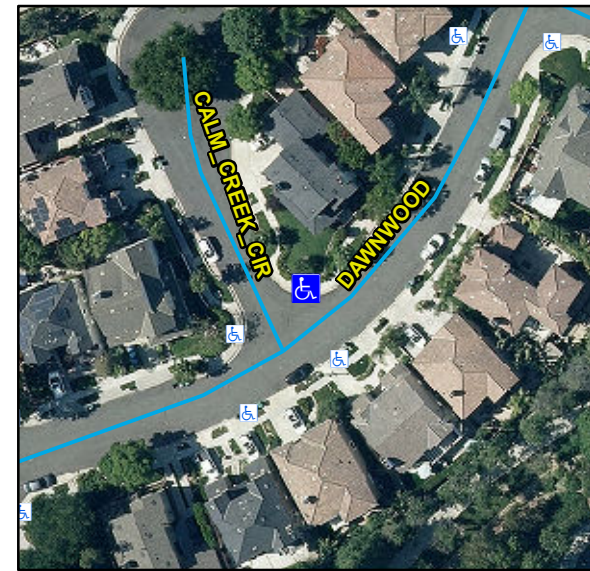
| Compliance | Description | Data | Compliance | Description | Data |
|---|---|---|---|---|---|
| Yes | Ramp Run Slope LT (%) | 1.9 | No | Ramp Run Slope RT (%) | 8.7 |
| N/A | Gutter Cross Slope (%) | N/A | No | Perpendicular Joint Present | No |

**Remove & Replace Curb Ramp With Two New Directional Ramps or Equivalent.**

**R204.3, R304.3.2, STD 1115**

Total Cost: \$ 4000

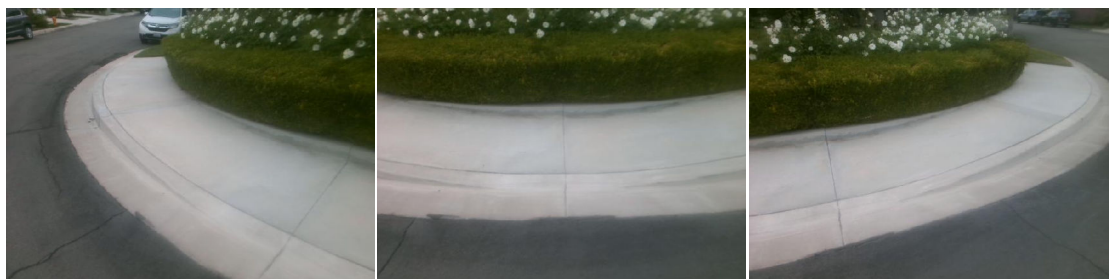
| Compliance | Description | Data | Compliance | Description | Data |
|---|---|---|---|---|---|
| N/A | Ramp Length LT (in) | 107 | N/A | Ramp Length RT (in) | 116 |
| Yes | Ramp Width LT (in) | 53 | Yes | Ramp Width RT (in) | 53 |
| Yes | Ramp Cross Slope LT (%) | 1.1 | Yes | Ramp Cross Slope RT (%) | 0.2 |
