# Access Compliance Report Public Rights-of-Way (Curb Ramps)

Main Street: DAWNWOOD Cross Street: CALM\_CREEK\_CIR Location: NW

ADA ID: RPRK211025115404 Ramp Type: Type 4 - Parallel Initial Pass/Fail: Pass Overall Compliance: No Severity Score: 25

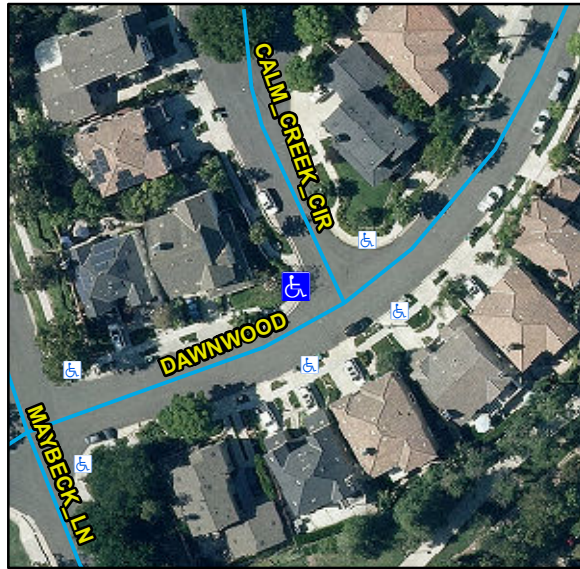
| Compliance | Description | Data | Compliance | Description | Data |
|---|---|---|---|---|---|
| N/A | Landing Present | No | No | DWS Provided | No |
| No | Landing Width (in) | N/A | N/A | DWS Length (in) | N/A |
| No | Landing Run Slope (%) | N/A | N/A | DWS Full Width | N/A |
| No | Landing Cross Slope (%) | N/A | | DWS Offset Type | N/A |
| No | Gutter Run Slope (%) | 9 | | Road Cross Slope (%) | 2.3 |

Remove & Replace Curb Ramp With Two New Directional Ramps or Equivalent. Remove & Replace Gutter.
