# Access Compliance Report Public Rights-of-Way (Curb Ramps)

Main Street: MAYBECK\_LN Cross Street: DAWNWOOD Location: NE

ADA ID: RPRK211025115612 Ramp Type: Type 4 - Parallel Initial Pass/Fail: Pass Overall Compliance: No Severity Score: 26

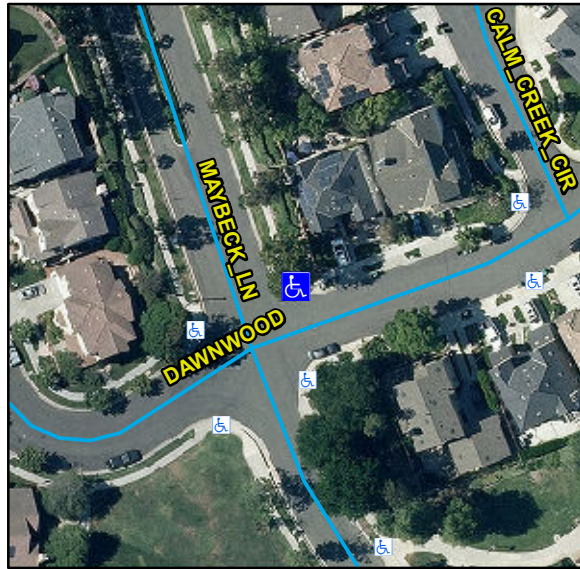
| Compliance | Description | Data | Compliance | Description | Data |
|---|---|---|---|---|---|
| No | Ramp Cross Slope LT (%) | 3.1 | No | Ramp Cross Slope RT (%) | 3.2 |
| No | Gutter Run Slope (%) | 11.7 | | Road Cross Slope (%) | 2.3 |
| No | Gutter Cross Slope (%) | 3.4 | No | Perpendicular Joint Present | No |

Remove & Replace Curb Ramp With Two New Directional Ramps or Equivalent. Remove & Replace Gutter.
