# Access Compliance Report Public Rights-of-Way (Curb Ramps)

Main Street: DAWNWOOD Cross Street: MAYBECK\_LN Location: NW

ADA ID: RPRK211025115907 Ramp Type: Type 4 - Parallel Initial Pass/Fail: Pass Overall Compliance: No Severity Score: 25

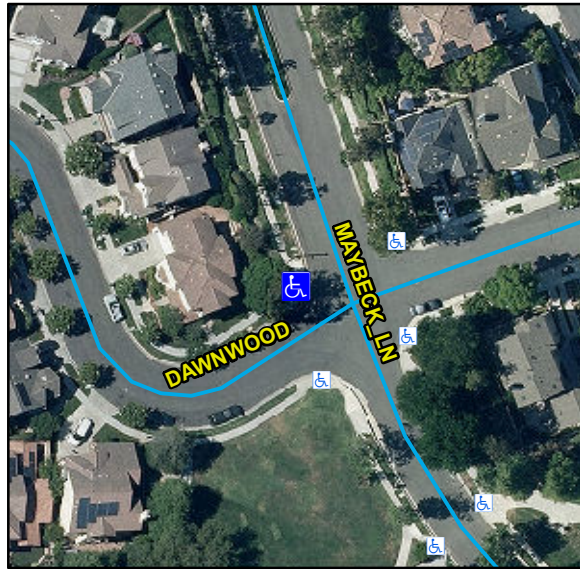
| Compliance | Description | Data | Compliance | Description | Data |
|---|---|---|---|---|---|
| Yes | Ramp Run Slope LT (%) | 7.9 | Yes | Ramp Run Slope RT (%) | 3.8 |
| N/A | Landing Present | No | No | DWS Provided | No |
| No | Landing Width (in) | N/A | N/A | DWS Length (in) | N/A |
| No | Landing Run Slope (%) | N/A | N/A | DWS Full Width | N/A |
| No | Landing Cross Slope (%) | N/A | | DWS Offset Type | N/A |
| No | Gutter Run Slope (%) | 5.8 | | Road Cross Slope (%) | 2.9 |

Remove & Replace Curb Ramp With Two New Directional Ramps or Equivalent. Remove & Replace Gutter.

R204.3, R304.2.1, R304.2.2-Perp, R304.3.2-Para, R304.5.3, R305, R304.5.4, STD 1115
