# Access Compliance Report Public Rights-of-Way (Curb Ramps)

| Main Street: ALGERWOOD | | Cross Street: DAWNWOOD | | Location: | SW |
| ADA ID: RPRK211025120453 | Ramp Type: Type 4 - Parallel | Initial Pass/Fail: Fail | Overall Compliance: No | Severity Score: | 2 |

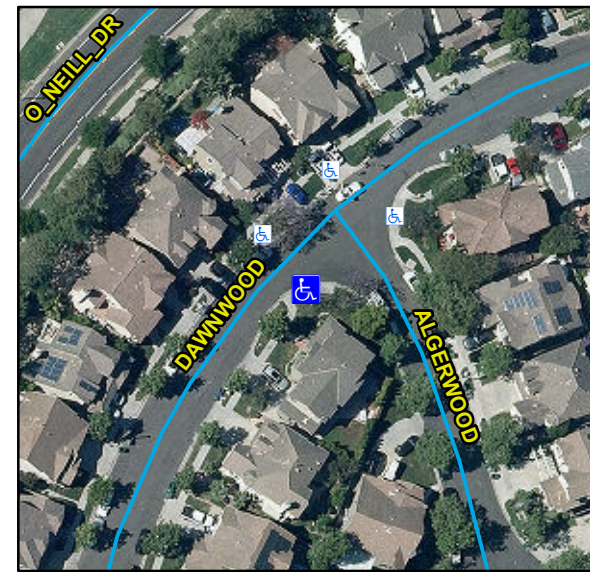
| Compliance | Description | Data | Compliance | Description | Data |
|---|---|---|---|---|---|
| No | Ramp Cross Slope LT (%) | 2.2 | No | Ramp Cross Slope RT (%) | 4.2 |
| N/A | Gutter Cross Slope (%) | N/A | No | Perpendicular Joint Present | No |

**Remove & Replace Curb Ramp With Two New Directional Ramps or Equivalent.**

**R204.3, R304.5.3, STD 1115**

Total Cost: \$ 4000
