# Access Compliance Report Public Rights-of-Way (Curb Ramps)

Main Street: DAWNWOOD Cross Street: ALGERWOOD Location: SE

ADA ID: RPRK211025120729 Ramp Type: Type 4 - Parallel Initial Pass/Fail: Fail Overall Compliance: No Severity Score: 20

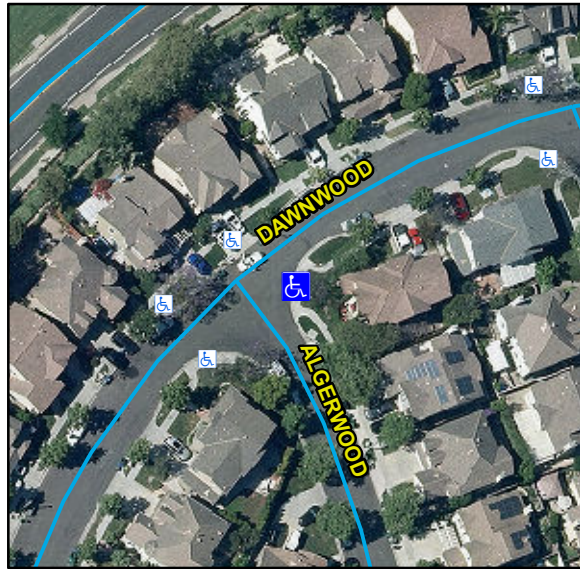
| Compliance | Description | Data | Compliance | Description | Data |
|---|---|---|---|---|---|
| No | Ramp Width LT (in) | 47 | No | Ramp Width RT (in) | 47 |
| No | Ramp Run Slope LT (%) | 8.8 | Yes | Ramp Run Slope RT (%) | 5.1 |
| No | Ramp Cross Slope LT (%) | 3.8 | No | Ramp Cross Slope RT (%) | 2.4 |

Remove & Replace Curb Ramp With Two New Directional Ramps or Equivalent.
