# Access Compliance Report Public Rights-of-Way (Curb Ramps)

Main Street: **EARLYWOOD** Cross Street: **DAWNWOOD** Location: **SW**

ADA ID: **RPRK211025120925** Ramp Type: **Type 4 - Parallel** Initial Pass/Fail: **Fail** Overall Compliance: **No** Severity Score: **2**

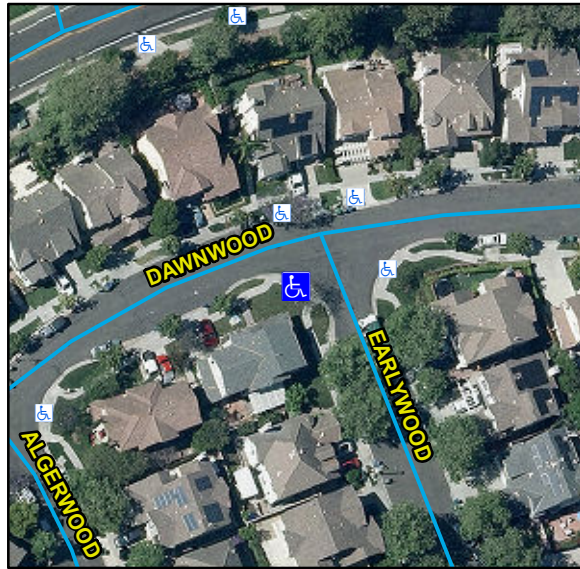
| Compliance | Description | Data | Compliance | Description | Data |
|---|---|---|---|---|---|
| <b>No</b> | Ramp Cross Slope LT (%) | <b>3.5</b> | <b>Yes</b> | Ramp Cross Slope RT (%) | <b>1.9</b> |

**Remove & Replace Curb Ramp With Two New Directional Ramps or Equivalent.**

**R204.3, R304.5.3, STD 1115**
