# Access Compliance Report Public Rights-of-Way (Curb Ramps)

Main Street: DAWNWOOD Cross Street: EARLYWOOD Location: SE

ADA ID: RPRK211025121147 Ramp Type: Type 4 - Parallel Initial Pass/Fail: Fail Overall Compliance: No Severity Score: 5

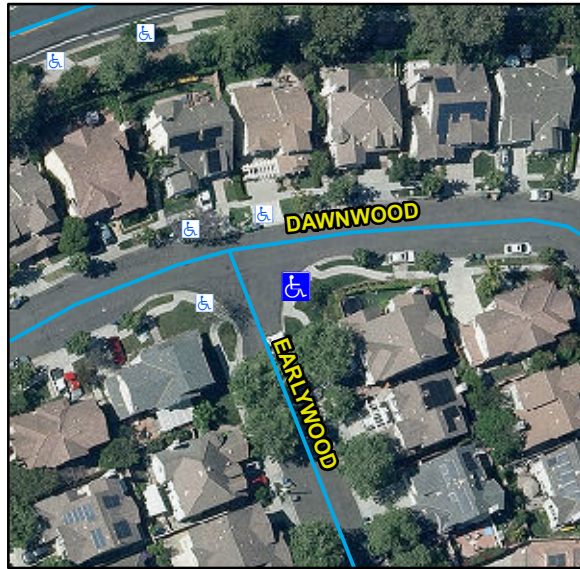
| Compliance | Description | Data | Compliance | Description | Data |
|---|---|---|---|---|---|
| No | Ramp Width LT (in) | 47 | No | Ramp Width RT (in) | 47 |
| No | Ramp Cross Slope LT (%) | 3.5 | No | Ramp Cross Slope RT (%) | 2.2 |

**Remove & Replace Curb Ramp With Two New Directional Ramps or Equivalent.**

**R204.3, R304.5.1, R304.5.3, STD 1115**
