# Access Compliance Report Public Rights-of-Way (Curb Ramps)

Main Street: MAYBECK\_LN Cross Street: DAWNWOOD Location: SW

ADA ID: RPRK211025121401 Ramp Type: Type 4 - Parallel Initial Pass/Fail: Fail Overall Compliance: No Severity Score: 15

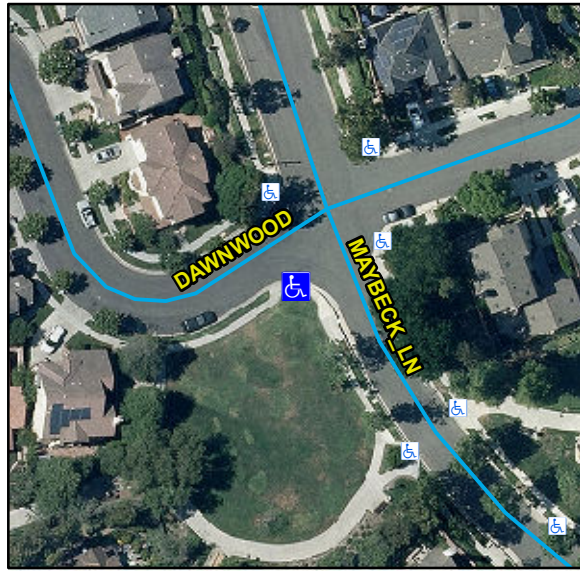
| Compliance | Description | Data | Compliance | Description | Data |
|---|---|---|---|---|---|
| No | Ramp Run Slope LT (%) | 11.3 | Yes | Ramp Run Slope RT (%) | 0.2 |

**Remove & Replace Curb Ramp With Two New Directional Ramps or Equivalent.**

**R204.3, R304.3.2, STD 1115**
