Access Compliance Report Public Rights-of-Way (Curb Ramps)

Main Street: MAYBECK_LN **Cross Street:** O_NEILL_DR **Location:** SW

ADA ID: RPRK211025121757 **Ramp Type:** Type 1 - Perpendicular Diagonal Initial Pass/Fail: Pass **Overall Compliance:** No **Severity Score:** 19

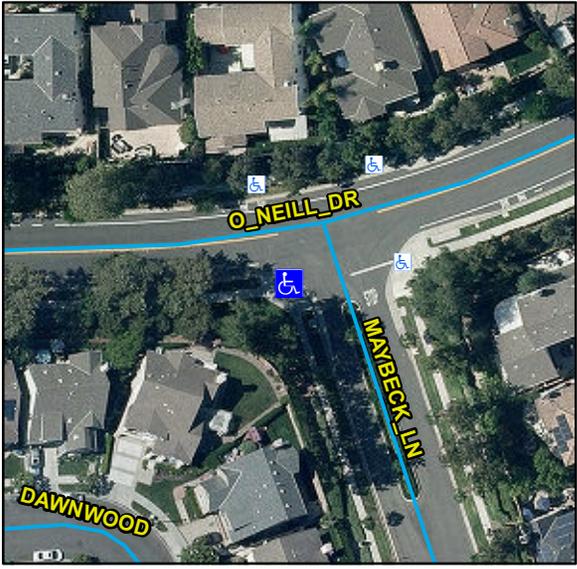
Compliance	Description	Data	Compliance	Description	Data
N/A	Ramp Length (in)	119	N/A	Flare Type LT	
Yes	Ramp Width (in)	48		Flare Slope LT (%)	3.2
Yes	Ramp Run Slope (%)	7.5	Yes	Flare Traversable LT	Yes
Yes	Ramp Cross Slope (%)	1.2	N/A	Flare Type RT	
N/A	Landing Present	Yes		Flare Slope RT (%)	6.3
N/A	Landing Length (in)	39	N/A	Flare Traversable RT	Yes
Yes	Landing Width (in)	48	Yes	DWS Provided	No
No	Landing Run Slope (%)	5.7	N/A	DWS Contrast	N/A
Yes	Landing Cross Slope (%)	1.2	No	DWS Length (in)	N/A
N/A	Landing Movement Obstructed?	No	N/A	DWS Full Width	N/A
	Landing Movement Type	N/A	N/A	DWS Offset Left (in)	N/A
N/A	Landing Shared	No	N/A	DWS Offset Right (in)	N/A
N/A	Clear Space	Yes	N/A	Marked Crosswalk 1	No
N/A	Clear Space To Crosswalk (in)	48	N/A	Crossing 1 Direction	E
N/A	Marked Crosswalk 1	No	N/A	Crossing 2 Direction	N
	Marked Crosswalk 1 Width (in)	N/A		Marked Crosswalk 2	No
N/A	Ramp Inside Crosswalk 1	N/A	Yes	Marked Crosswalk 2 Width (in)	N/A

Crossing 1 Slope (%)	1.9		Ramp Inside Crosswalk 2	N/A
	Crossing 1 Cross Slope (%)	0.7		Crossing 1 Slope (%)	2.6
Yes	Gutter Ponding	No	No	Crossing 2 Slope (%)	1.2
Yes	Gutter Lip Height (in)	0		Crossing 2 Cross Slope (%)	13.7
Yes	Gutter Run Slope (%)	4.5		Curb Slope	1
No	Gutter Cross Slope (%)	2.1		Road Run Slope (%)	0.8
Yes	Overall Surface Condition: Acceptable		No	Road Cross Slope (%)	
	Cross Gutter Present?	No		Perp Joint Present	No
	Replace Cross Gutter?	N/A		Spandrel Present?	No
				Replace Spandrel?	N/A

Possible Solutions:
Remove & Replace Curb Ramp With Two New Directional Ramps or Equivalent. Remove & Replace Gutter.
