# Access Compliance Report Public Rights-of-Way (Curb Ramps)

Main Street: O\_NEILL\_DR Cross Street: MAYBECK\_LN Location: SE

ADA ID: RPRK211025122135 Ramp Type: Type 1 - Perpendicular Diagonal Initial Pass/Fail: Fail Overall Compliance: No Severity Score: 2

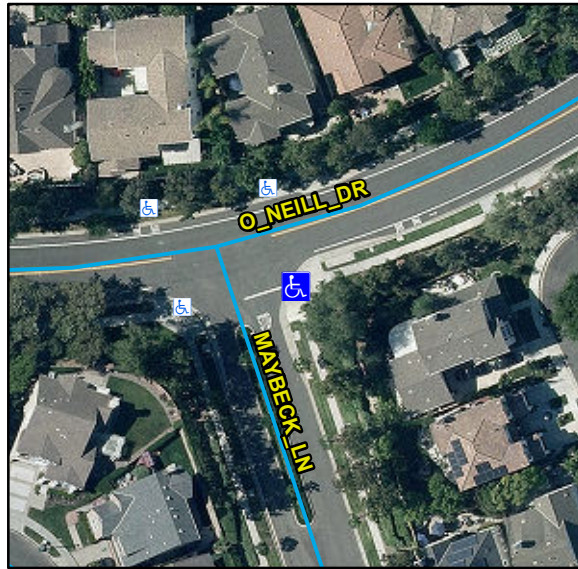
| Compliance | Description | Data | Compliance | Description | Data |
|---|---|---|---|---|---|
| No | Ramp Cross Slope (%) | 4.6 | N/A | Flare Traversable LT | N/A |

Remove & Replace Curb Ramp With Two New Directional Ramps or Equivalent.
