# Access Compliance Report Public Rights-of-Way (Curb Ramps)

Main Street: O\_NEILL\_DR Cross Street: MAYBECK\_LN Location: N

ADA ID: RPRK211025122325 Ramp Type: Type 1 - Perpendicular Initial Pass/Fail: Pass Overall Compliance: No Severity Score: 25

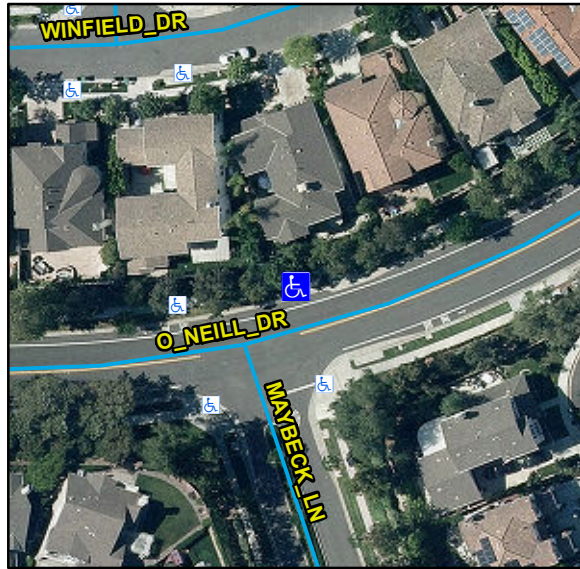
| Compliance | Description | Data | Compliance | Description | Data |
|---|---|---|---|---|---|
| No | Landing Width (in) | N/A | N/A | Flare Slope RT (%) | 14.7 |
| No | Landing Run Slope (%) | N/A | N/A | Flare Traversable RT | No |
| No | Landing Cross Slope (%) | N/A | No | DWS Provided | No |
| Yes | Gutter Ponding | No | No | Curb Slope | 9.4 |
| No | Gutter Run Slope (%) | 10.4 | | Road Cross Slope (%) | N/A |

Remove & Replace Entire Ramp. Remove & Replace Gutter.
