# Access Compliance Report Public Rights-of-Way (Curb Ramps)

Main Street: WINFIELD\_DR Cross Street: O\_NEILL\_DR Location: NE

ADA ID: RPRK211025122649 Ramp Type: Type 1 - Perpendicular Diagonal Initial Pass/Fail: Fail Overall Compliance: No Severity Score: 15

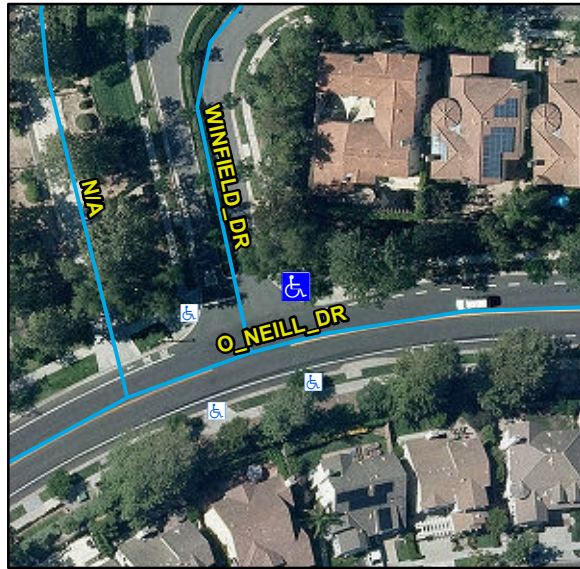
| Compliance | Description | Data | Compliance | Description | Data |
|---|---|---|---|---|---|
| No | Ramp Run Slope (%) | 8.7 | N/A | Flare Slope LT (%) | N/A |

Remove & Replace Curb Ramp With Two New Directional Ramps or Equivalent.

R204.3, R304.2.2, STD 1115
