# Access Compliance Report Public Rights-of-Way (Curb Ramps)

Main Street: O\_NEILL\_DR Cross Street: WINFIELD\_DR Location: NW

ADA ID: RPRK211025122856 Ramp Type: Type 1 - Perpendicular Diagonal Initial Pass/Fail: Pass Overall Compliance: No Severity Score: 20

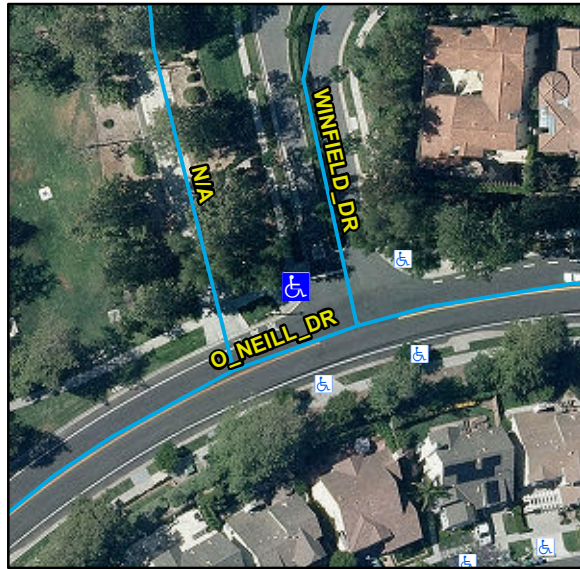
| Compliance | Description | Data | Compliance | Description | Data |
|---|---|---|---|---|---|
| No | Landing Run Slope (%) | 3 | N/A | Flare Traversable RT | Yes |
| No | Landing Cross Slope (%) | 3 | No | DWS Provided | No |
| Yes | Gutter Ponding | No | No | Curb Slope | 14.6 |
| No | Gutter Run Slope (%) | 6.8 | | Road Cross Slope (%) | 1.2 |

Remove & Replace Curb Ramp With Two New Directional Ramps or Equivalent. Remove & Replace Gutter.
