# Access Compliance Report Public Rights-of-Way (Curb Ramps)

Main Street: O\_NEILL\_DR Cross Street: WINFIELD\_DR Location: SW

ADA ID: RPRK211025123148 Ramp Type: Type 1 - Perpendicular Initial Pass/Fail: Pass Overall Compliance: No Severity Score: 25

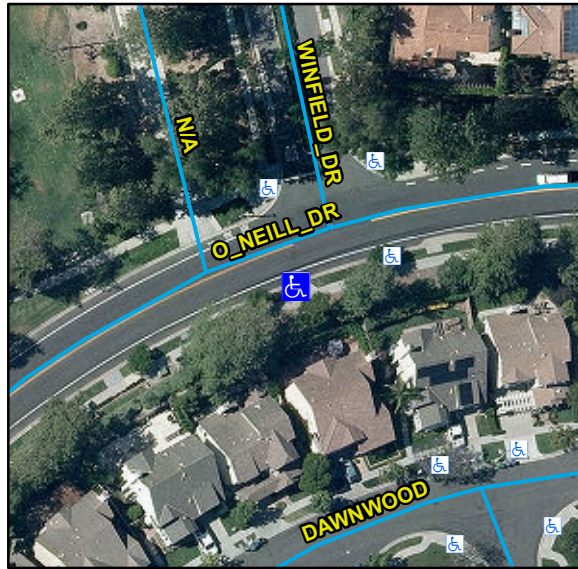
| Compliance | Description | Data | Compliance | Description | Data |
|---|---|---|---|---|---|
| No | Landing Width (in) | N/A | N/A | Flare Slope RT (%) | 9.8 |
| No | Landing Run Slope (%) | N/A | N/A | Flare Traversable RT | No |
| No | Landing Cross Slope (%) | N/A | No | DWS Provided | No |
| Yes | Gutter Ponding | No | No | Curb Slope | 13.6 |
| No | Gutter Run Slope (%) | 13.6 | | Road Cross Slope (%) | N/A |

Remove & Replace Entire Ramp. Remove & Replace Gutter.
