# Access Compliance Report Public Rights-of-Way (Curb Ramps)

Main Street: WINFIELD\_DR Cross Street: MASON\_LN Location: NW

ADA ID: RPRK211025123617 Ramp Type: Type 4 - Parallel Initial Pass/Fail: Fail Overall Compliance: No Severity Score: 2

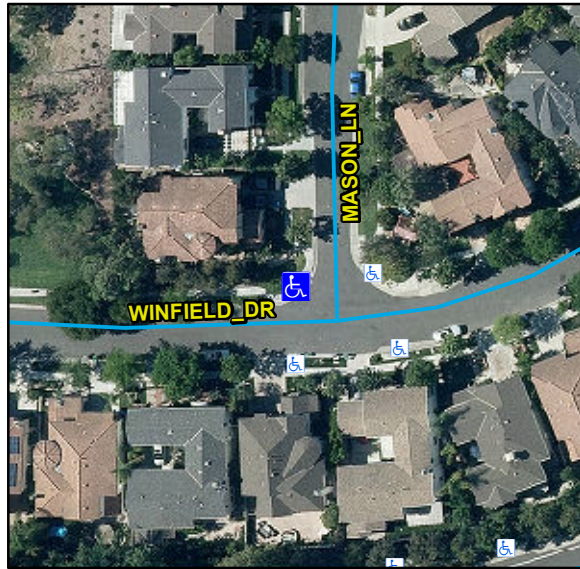
| Compliance | Description | Data | Compliance | Description | Data |
|---|---|---|---|---|---|
| Yes | Ramp Cross Slope LT (%) | 1.3 | No | Ramp Cross Slope RT (%) | 2.2 |

Remove & Replace Curb Ramp With Two New Directional Ramps or Equivalent.

R204.3, R304.5.3, STD 1115
