# Access Compliance Report Public Rights-of-Way (Curb Ramps)

Main Street: MASON\_LN Cross Street: WINFIELD\_DR Location: NE

ADA ID: RPRK211025123815 Ramp Type: Type 4 - Parallel Initial Pass/Fail: Fail Overall Compliance: No Severity Score: 2

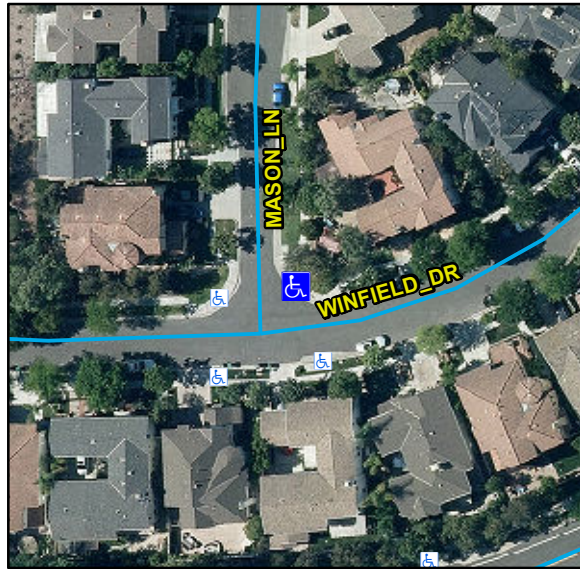
| Compliance | Description | Data | Compliance | Description | Data |
|---|---|---|---|---|---|
| No | Ramp Cross Slope LT (%) | 2.5 | Yes | Ramp Cross Slope RT (%) | 0.4 |
| N/A | Gutter Ponding | N/A | No | Curb Slope | 9.8 |
| N/A | Gutter Cross Slope (%) | N/A | No | Perpendicular Joint Present | No |

**Remove & Replace Curb Ramp With Two New Directional Ramps or Equivalent.**

**R304.2.2, R204.3, R304.5.3, STD 1115**

Total Cost: \$ 4000
