# Access Compliance Report Public Rights-of-Way (Curb Ramps)

Main Street: MCGWIRE\_RD Cross Street: N/A Location: N

ADA ID: RPRK211025130825 Ramp Type: Type 1 - Perpendicular Diagonal Initial Pass/Fail: Fail Overall Compliance: No Severity Score: 45

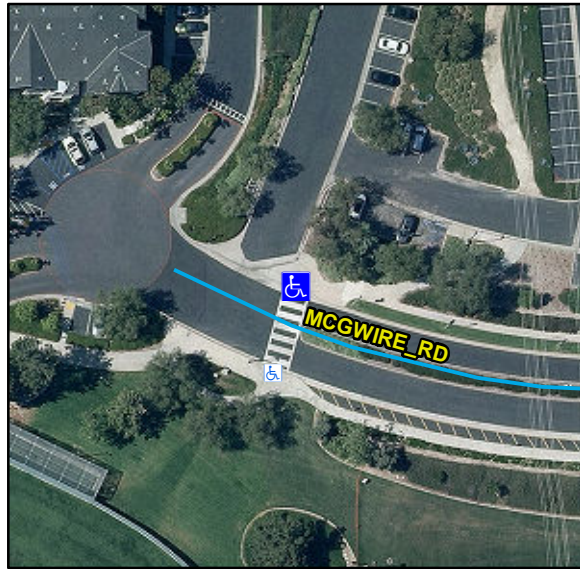
| Compliance | Description | Data | Compliance | Description | Data |
|---|---|---|---|---|---|
| No | Ramp Run Slope (%) | 15.1 | N/A | Flare Slope LT (%) | N/A |
| No | Ramp Cross Slope (%) | 6.1 | N/A | Flare Traversable LT | N/A |

Remove & Replace Curb Ramp With Two New Directional Ramps or Equivalent.

R304.2.2, R204.3, R304.5.3, STD 1115
