# Access Compliance Report Public Rights-of-Way (Curb Ramps)

Main Street: MCGWIRE\_RD Cross Street: MCGWIRE\_RD Location: S

ADA ID: RPRK211025131047 Ramp Type: Type 1 - Perpendicular Initial Pass/Fail: Fail Overall Compliance: No Severity Score: 30

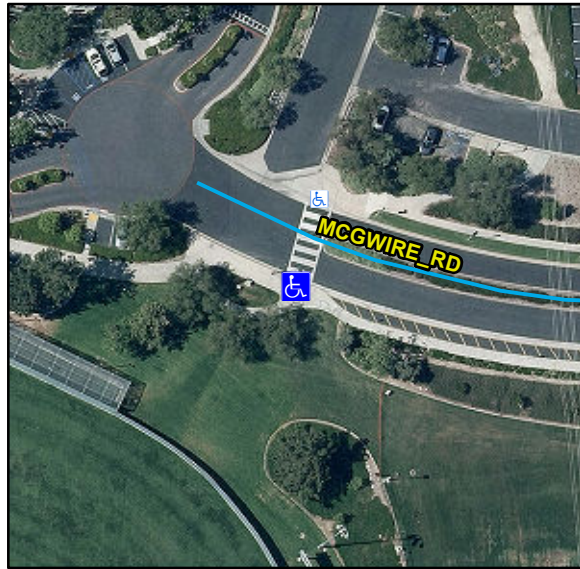
| Compliance | Description | Data | Compliance | Description | Data |
|---|---|---|---|---|---|
| No | Ramp Run Slope (%) | 8.9 | N/A | Flare Slope LT (%) | N/A |
| No | Ramp Cross Slope (%) | 6.3 | N/A | Flare Traversable LT | N/A |

Remove & Replace Entire Ramp.
