# Access Compliance Report Public Rights-of-Way (Curb Ramps)

Main Street: O\_NEILL\_DR Cross Street: MCGWIRE\_RD Location: SW

ADA ID: RPRK211025131223 Ramp Type: Type 1 - Perpendicular Diagonal Initial Pass/Fail: Fail Overall Compliance: No Severity Score: 2

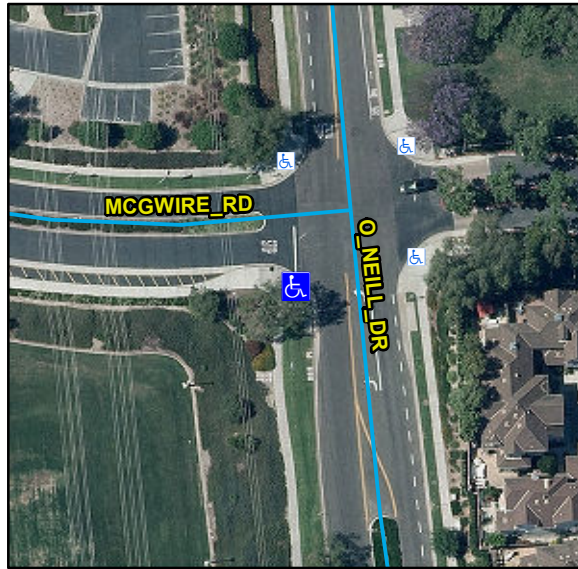
| Compliance | Description | Data | Compliance | Description | Data |
|---|---|---|---|---|---|
| No | Ramp Cross Slope (%) | 3.6 | N/A | Flare Traversable LT | N/A |

Remove & Replace Curb Ramp With Two New Directional Ramps or Equivalent.

R304.2.2, R204.3, R304.5.3, STD 1115
