# Access Compliance Report Public Rights-of-Way (Curb Ramps)

Main Street: CROWN\_VALLEY\_PKWY Cross Street: O\_NEILL\_DR Location: NW

ADA ID: RPRK211025131900 Ramp Type: Type 1 - Perpendicular Initial Pass/Fail: Fail Overall Compliance: No Severity Score: 15

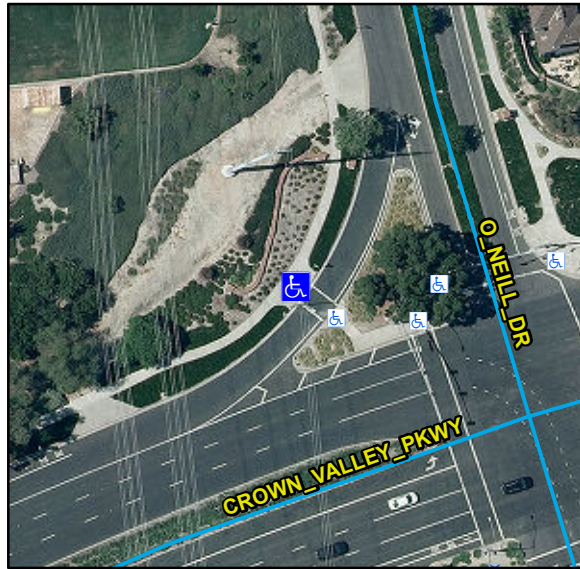
R304.2.2, R204.3, STD 1115

| Compliance | Description | Data | Compliance | Description | Data |
|---|---|---|---|---|---|
| No | Ramp Run Slope (%) | 8.9 | N/A | Flare Slope LT (%) | N/A |

Remove & Replace Entire Ramp.
