# Access Compliance Report Public Rights-of-Way (Curb Ramps)

| Main Street: CROWN_VALLEY_PKWY | | Cross Street: O_NEILL_DR | | Location: | NW |
| ADA ID: RPRK211025132031 | Ramp Type: Type 1 - Perpendicular | Initial Pass/Fail: Fail | Overall Compliance: No | Severity Score: | 16 |

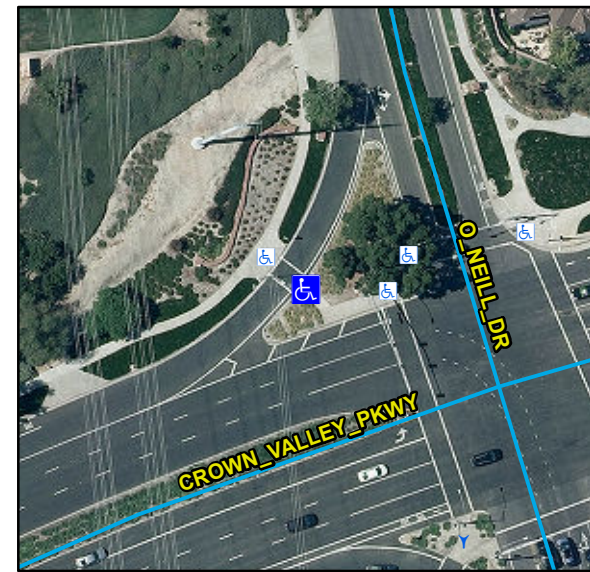
| Compliance | Description | Data | Compliance | Description | Data |
|---|---|---|---|---|---|
| No | Ramp Run Slope (%) | 9.1 | N/A | Flare Slope LT (%) | N/A |
| No | Ramp Cross Slope (%) | 3.4 | N/A | Flare Traversable LT | N/A |

Remove & Replace Entire Ramp.

R204.3, R304.2.2, R304.5.3, STD 1115

Total Cost: \$ 3080
