# Access Compliance Report Public Rights-of-Way (Curb Ramps)

Main Street: CROWN\_VALLEY\_PKWY Cross Street: O\_NEILL\_DR Location: NW

ADA ID: RPRK211025132344 Ramp Type: Type 4 - Parallel Initial Pass/Fail: Fail Overall Compliance: No Severity Score: 16

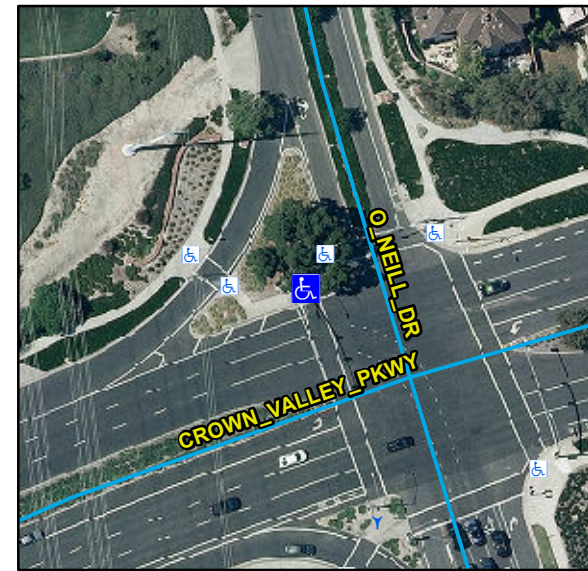
| Compliance | Description | Data | Compliance | Description | Data |
|---|---|---|---|---|---|
| Yes | Ramp Run Slope LT (%) | 2.2 | No | Ramp Run Slope RT (%) | 9.8 |
| Yes | Ramp Cross Slope LT (%) | 1.1 | No | Ramp Cross Slope RT (%) | 4.2 |

Remove & Replace Entire Ramp.

R204.3, R304.3.2, R304.5.3, STD 1115
