# Access Compliance Report Public Rights-of-Way (Curb Ramps)

| Main Street: O_NEILL_DR | | Cross Street: CROWN_VALLEY_PKWY | | Location: | NW |
| ADA ID: RPRK211025135043 | Ramp Type: Type 4 - Parallel | Initial Pass/Fail: Fail | Overall Compliance: No | Severity Score: | 15 |

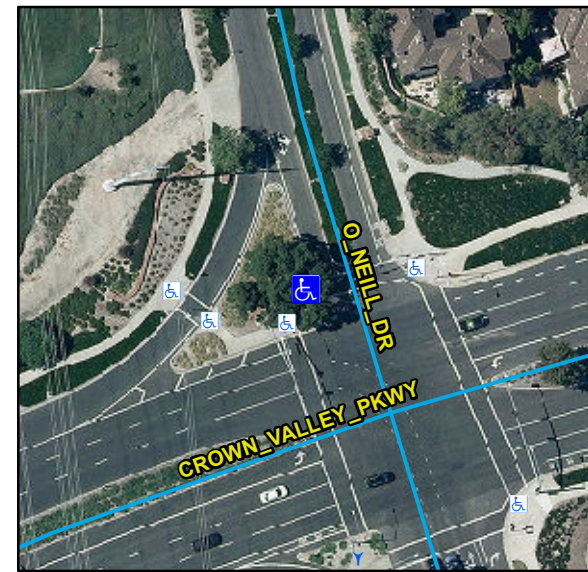
| Compliance | Description | Data | Compliance | Description | Data |
|---|---|---|---|---|---|
| Yes | Ramp Run Slope LT (%) | 3.8 | No | Ramp Run Slope RT (%) | 9.8 |

**Remove & Replace Entire Ramp.**

**R204.3, R304.3.2, STD 1115**
