# Access Compliance Report Public Rights-of-Way (Curb Ramps)

Main Street: O\_NEILL\_DR Cross Street: CROWN\_VALLEY\_PKWY Location: NE

ADA ID: RPRK211025135418 Ramp Type: Type 1 - Perpendicular Diagonal Initial Pass/Fail: Fail Overall Compliance: No Severity Score: 15

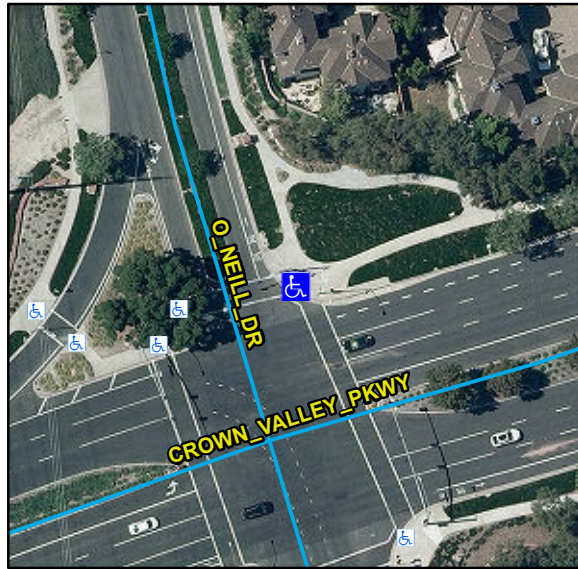
| Compliance | Description | Data | Compliance | Description | Data |
|---|---|---|---|---|---|
| No | Ramp Cross Slope (%) | 7 | N/A | Flare Traversable LT | N/A |

Remove & Replace Curb Ramp With Two New Directional Ramps or Equivalent.

R204.3, R304.5.3, STD 1115
