# Access Compliance Report Public Rights-of-Way (Curb Ramps)

Main Street: O\_NEILL\_DR Cross Street: CROWN\_VALLEY\_PKWY Location: SW

ADA ID: RPRK211025140605 Ramp Type: Type 1 - Perpendicular Initial Pass/Fail: Fail Overall Compliance: No Severity Score: 16

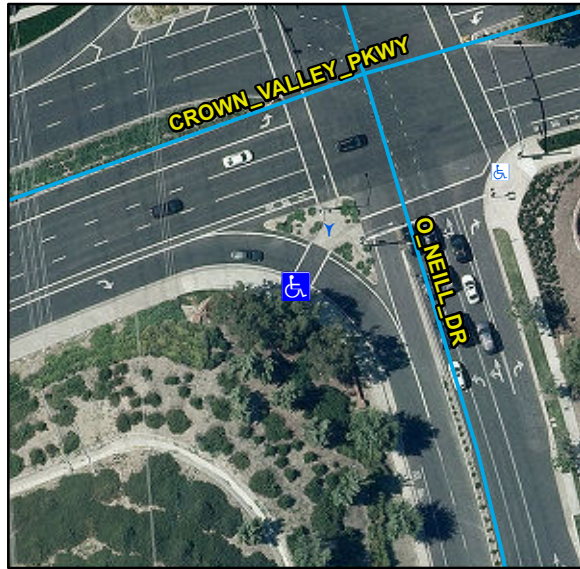
| Compliance | Description | Data | Compliance | Description | Data |
|---|---|---|---|---|---|
| No | Ramp Run Slope (%) | 11 | N/A | Flare Slope LT (%) | N/A |
| No | Ramp Cross Slope (%) | 2.8 | N/A | Flare Traversable LT | N/A |

Remove & Replace Entire Ramp.

R204.3, R304.2.2, R304.5.3, STD 1115

Total Cost: \$ 3080
