# Access Compliance Report Public Rights-of-Way (Curb Ramps)

Main Street: CECIL\_PASTURE\_RD Cross Street: O\_NEILL\_DR Location: NW

ADA ID: RPRK211025142458 Ramp Type: Type 4 - Parallel Initial Pass/Fail: Fail Overall Compliance: No Severity Score: 45

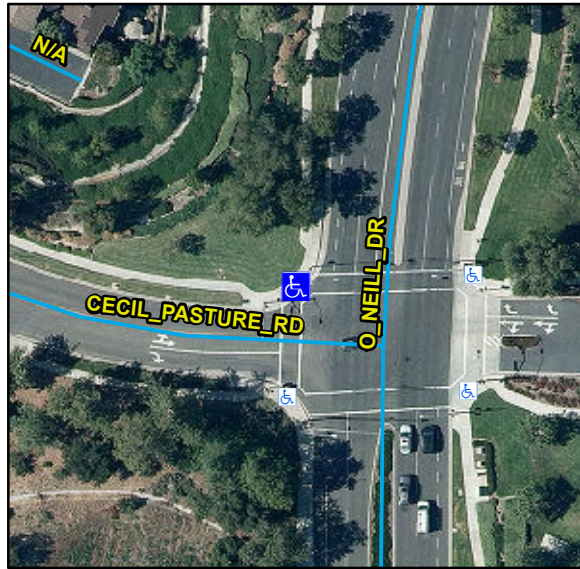
| Compliance | Description | Data | Compliance | Description | Data |
|---|---|---|---|---|---|
| No | Ramp Run Slope LT (%) | 8.7 | Yes | Ramp Run Slope RT (%) | 4.4 |
| Yes | Ramp Cross Slope LT (%) | 0.5 | No | Ramp Cross Slope RT (%) | 7.4 |

**Remove & Replace Curb Ramp With Two New Directional Ramps or Equivalent.**

**R204.3, R304.3.2, R304.5.3, STD 1115**
